# SERBIATRIB '15

14<sup>th</sup> International Conference on  
Tribology

## REDUCTION AND MAINTENANCE OF TURBOCHARGERS BY APPLYING VALID TRIBOLOGICAL CONSTRUCTING

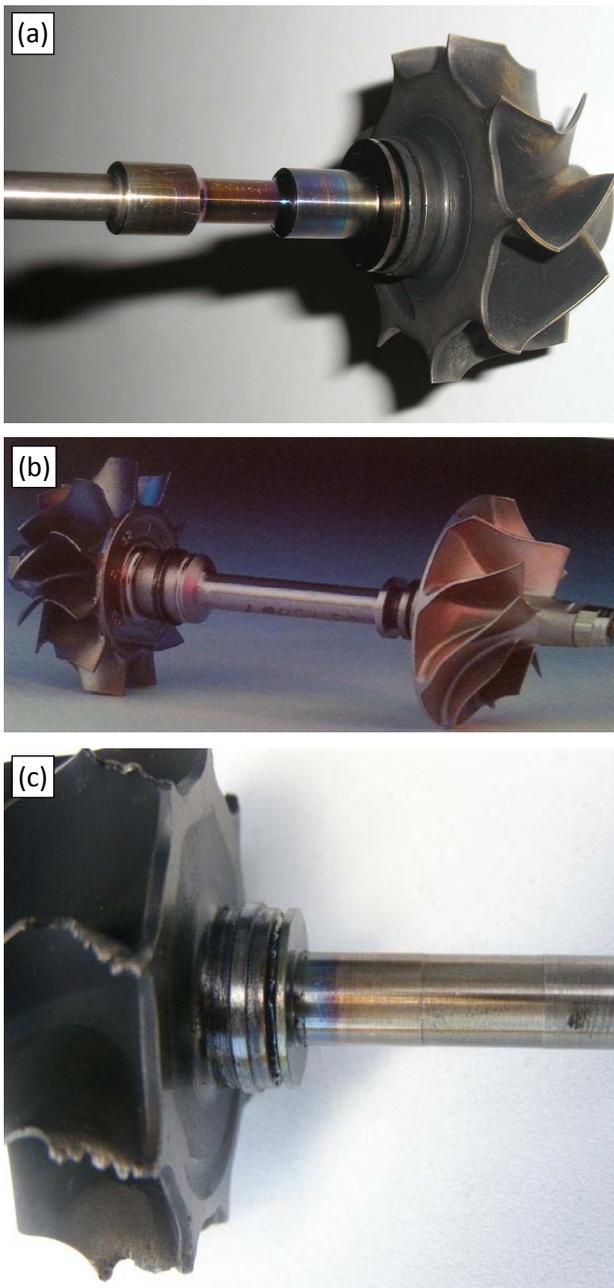
**Figure 2.** The characteristic appearance of damaged parts of turbochargers

- there is no visible damage on the housing of turbochargers,
- there is no visible damage on the compressor impeller,
- there is no visible damage on the turbine rotor,
- axle backlash is not increased, and
- visually it was found that the axle changed colour; colour of the axle towards the rotor blades of the impeller is from purple to dark red, Fig. 2c.

After the change of colour it is clear that there has been overheating, cause of overheating is insufficient cooling, axle is cooled with oil. Cause of damage is bad termination or termination of lubrication. Interruption of lubrication causes an increase of temperature in the bearings and increase of material wear, it occurs as a result of imbalance of rotating bodies: damage of the rotor and impeller.

1. Sensor for temperature of turbochargers which would not allow shutdown of the power aggregate until the temperature is lower and acceptable.
2. Separate lubrication system of the sliding bearing that is not connected to the lubrication system of the drive unit, with custom lubrication and with a separate cooling and drive pump that continues to work after stopping the drive unit.
3. Cooling housing of turbochargers with liquid which cools drive unit. In this solution, the problem is that the engine coolant temperature is 90 °C, and the temperature of the exhaust gas of the turbochargers is much higher and would require adjustment cooling system with larger refrigerators and plenty of coolant.

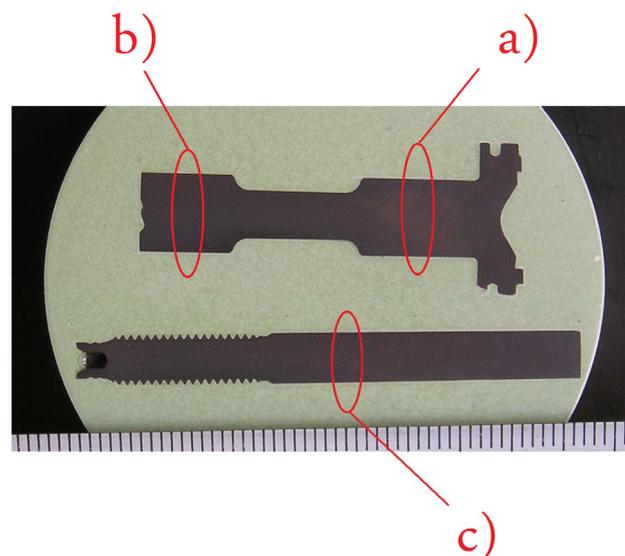
**Figure 3.** Positions of recording structure and microhardness measurements

On the parts of section “b” and “c” hardness is between 330 and 350 HV0.1. On section “a” (part of axle where you can see purple colour) hardness is from 420 to 430 HV0.1.

The measurement results confirm that in the heat affected zone has been a change of the material structure which is manifested by increasing hardness, in a layer located below the hardened layer has been a noticeable decline of decarburization and hardness. According to the change in the structure we know that the material was exposed to a temperature higher than the temperature of the austenitising.

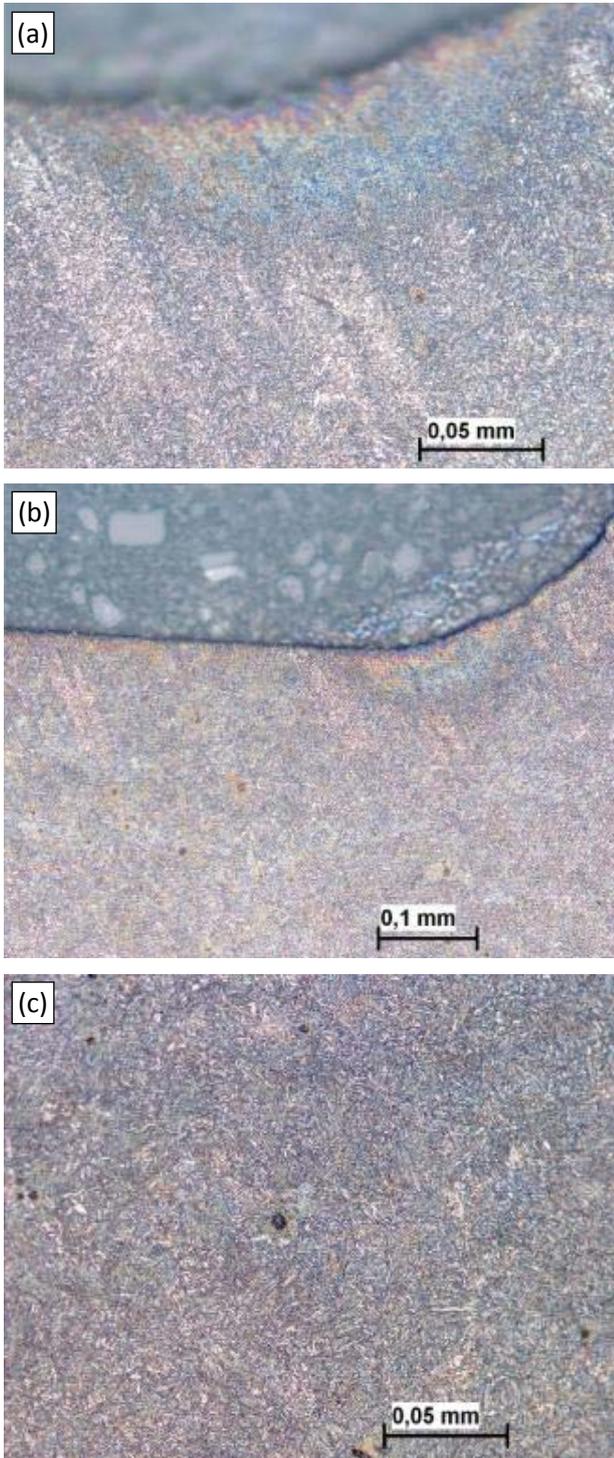
**Figure 4.** The characteristic microstructure of turbochargers damaged axle: (a) and (b) zones of overheating and (c) the core

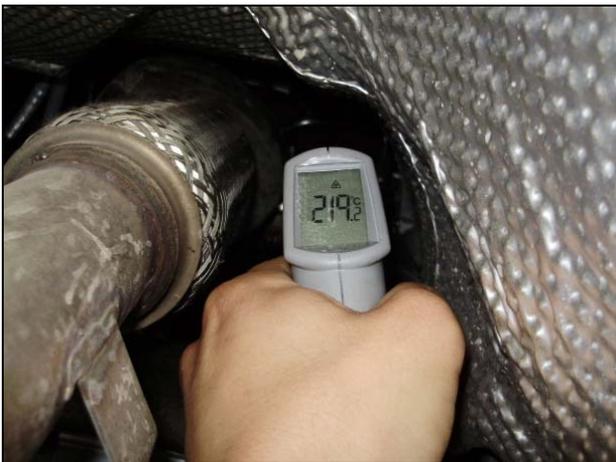
Testing of the working conditions at the temperature of normal load showed that the temperature does not exceed the extreme limits. Testing is performed on the work table, Fig. 5, at heavy load of turbocharger, 3440 rpm, Fig. 6.

Figure 5. Testing the turbocharger

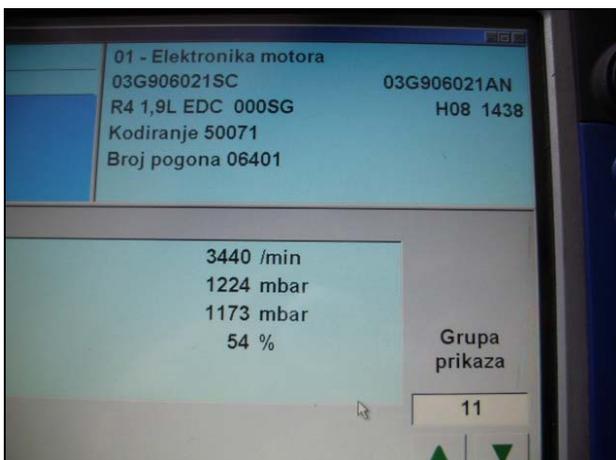
Figure 6. The pressure and temperature at 3440 rpm

The temperature of the engine coolant has reached 90 °C, and temperature on the housing slide bearing was 219.2 °C. For safety

The critical temperature at which the oil begins to fall apart at the lighter components and coke is quite low and only 360 °C, which does not satisfy. The results of the tests indicate that in extreme temperature conditions turbochargers may exceed the permissible temperature of the oil of 360 °C.
