BALKANTRIB'05
5th INTERNATIONAL CONFERENCE ON TRIBOLOGY
JUNE.15-18. 2005
Kragujevac, Serbia and Montenegro

REVIEW ON BALLISTIC TRIBOLOGY

A.Alper Cerit, M.Baki Karamış**, Fehmi Nair***

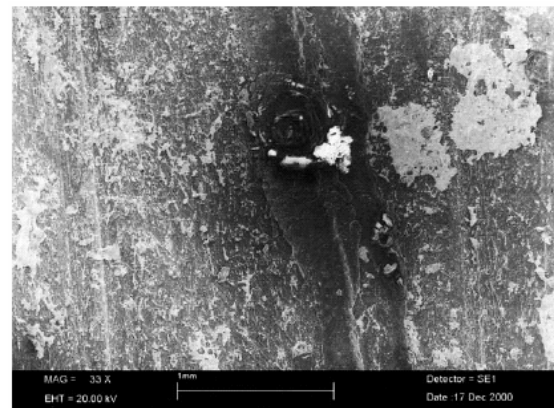
Fig. 3: The SiC particle transferred by rubbing the surface together with projectile [9].

is brought into contact with a SiC particle, the particle is transferred by rubbing the surface together with projectile (Fig. 3).

Therefore, the projectile surface is not in full contact with matrix surface. As a result of this kind of contact, three-body abrasion occurs. If

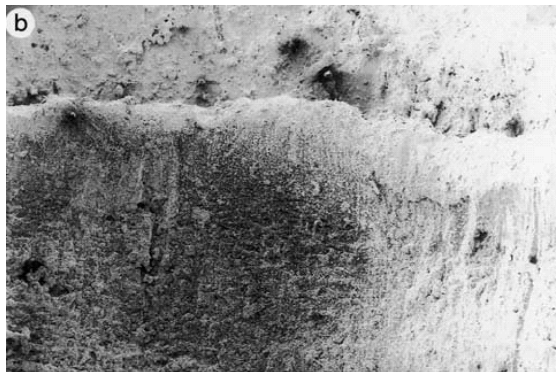
Fig. 4: The different regions of a hole surface [9].

When the hole surfaces were examined morphologically, some important changes were observed from the entrance to the exit side of the hole. It is observed that there were some differences of smoothness between the beginning and the end of the holes generated by projectile. Fig. 4 gives evidence for this situation. Where the projectile entered the material, a smoother hole surface occurred relatively. In contrast, a rough surface at the end of the hole is observed. The reason for this difference is that the projectile entered the material with a higher velocity while it is decelerated by the damping properties of the material at the end of the hole. The high velocity of the projectile leads to the melting of some surface layers because of the excess heating resulting from high velocity friction. The molten material flows out in the same direction with the projectile, and re-solidified at the interface leaved by projectile. Thus, the relatively smooth surfaces are occurred at the inner zone (Fig. 4a). On the other hand, at the end of the holes, the hole surface is rather rough (Fig. 4d). The

velocity of the projectile is slowed down by the material and the hole surface is coarsened by resulting from the lower velocity friction [9].

In addition to the alteration of the surface morphology explained above, another change is observed with chemical composition at different regions of the hole surface. It is surprising that, while copper and lead contents are high in the region (Fig. 4b), they gradually decrease at the region (Fig. 4c). Because, the copper rich jacket of the steel core is peeled and adhered to the surface in the relatively early stage of the penetration when the projectile moved in the material. Therefore, the copper and lead contents are enriched at the zone given in (Fig. 4b).

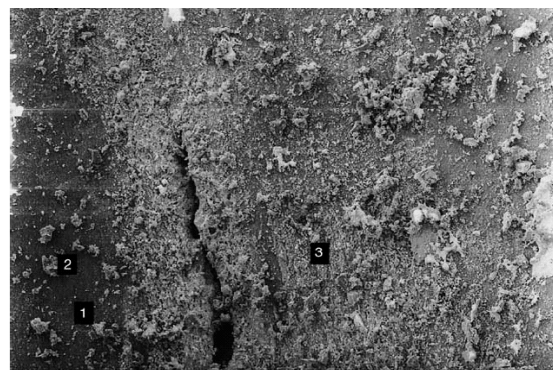
Fig. 5: The fracture surface of the hole (SiCp) [9].

It can be seen in the Fig. 5 that, deep cracking nearby the entrance surface of the hole has occurred with the projectile impact. Although

the projectile has higher velocity relatively at this region, the crack is appeared without plastic yielding due to the brittleness of the material. The presence of SiC particles in the region causes to brittleness and the neighborhood regions of particles are cracked by the shaking of the particles due to the impact. Many examples can be given for this situation even in the middle zone of the hole surface (Fig. 6) [9].

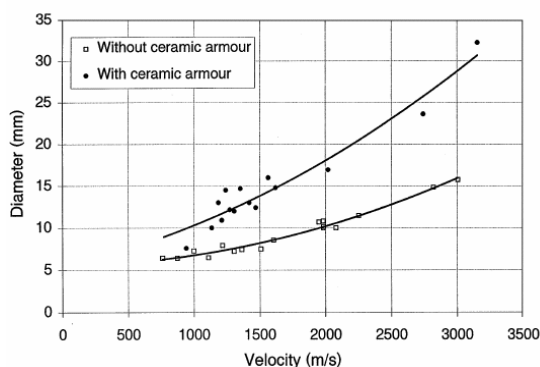
Fig. 10: Spread of damage measurements for the aluminium block with and without the ceramic faced Armour [13].
