SERBIATRIB '15

14th International Conference on Tribology

EXPERIMENTAL STUDY OF ADHESIVE WEAR OF A HOLDING DEVICE USING A CROSS CYLINDERS TESTER

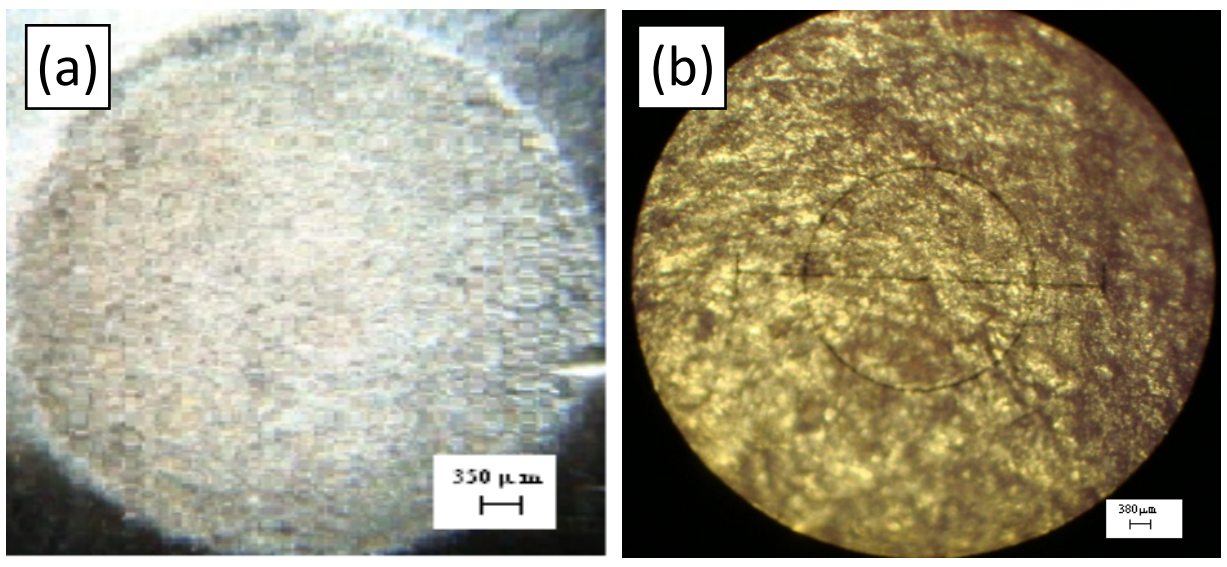
Figure 4. Wear scar features of a worn cylinder of the holding system: (a) 18 × and (b) 100 ×

In the Figure 2, can be seen the lateral contact for a single cylinder and the leaf spring. Figure 3 shows an elliptical worn area. The wear scar images taken by an optical microscope are shown in the Figures 4a and 4b. The contact between the cylinder and the leaf spring has an elliptical shape at 90°.

Adhesive wear damage can be observed on the scars. The wear is initiated by the interfacial junctions that form the cylinders and the leaf spring. When the load is applied the contact pressure turned extremely. It is believed that yield stress is exceeding deforming plastically until increase the contact area. The plastic deformation by impact was discarded because the tolerances between the cylinder and the leaf spring are extremely closed.

Figure 3. Wear zone on a cylindrical component

The wear scar examination showed that mild adhesive wear is generated through all the operation life of the cylinder. However, the wear is related to the number of times the holing operation is carried out. Thus, it is thought that the contact pressure has not had a significant relation to the process of wear.

The wear scars examination for the actual worn cylindrical components has shown mainly mild adhesive wear.

The overall work has shown that applied nitrinding to the AISI 9840R steel specimens and the cylinders of the holding device system was possible increased the wear life of the components. The wear rate was reduced down to 97 % compare to the untreated steel in dry conditions [5].

The rig used has shown that it is a suitable rig in order to simulated adhesive wear. It was only suggested to treat the AISI 9840 R steel and carry out the process in dry conditions since this represents a low cost maintenance cost and the treated material in dry conditions has shown its efficacy in terms of wear and friction.

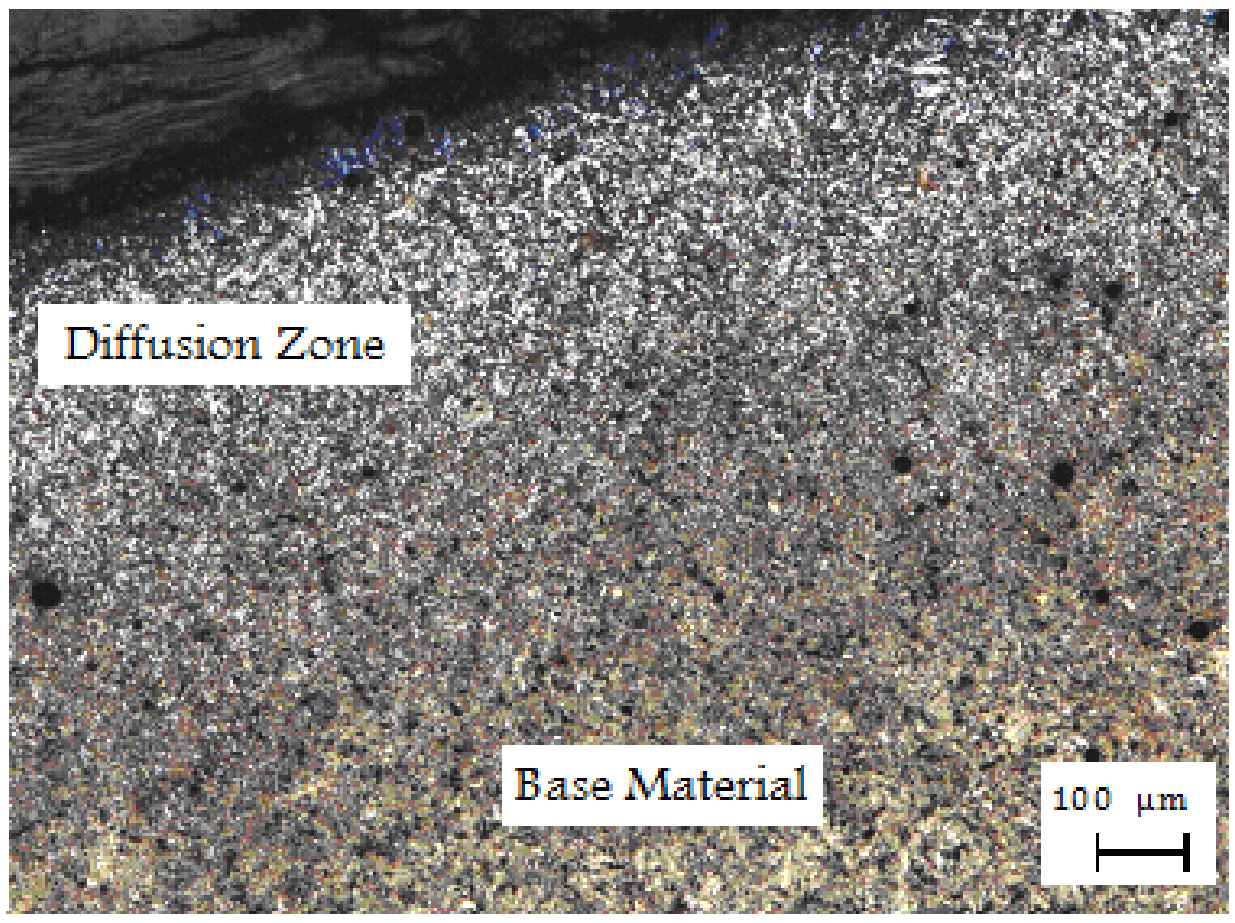
Figure 8. Thermal-chemical diffusion of nitriding

Figure 8 shows the diffusions of the thermal chemical nitriding diffusion into the base material. It is approximately 100 μm depth in AISI 9840 R steel.

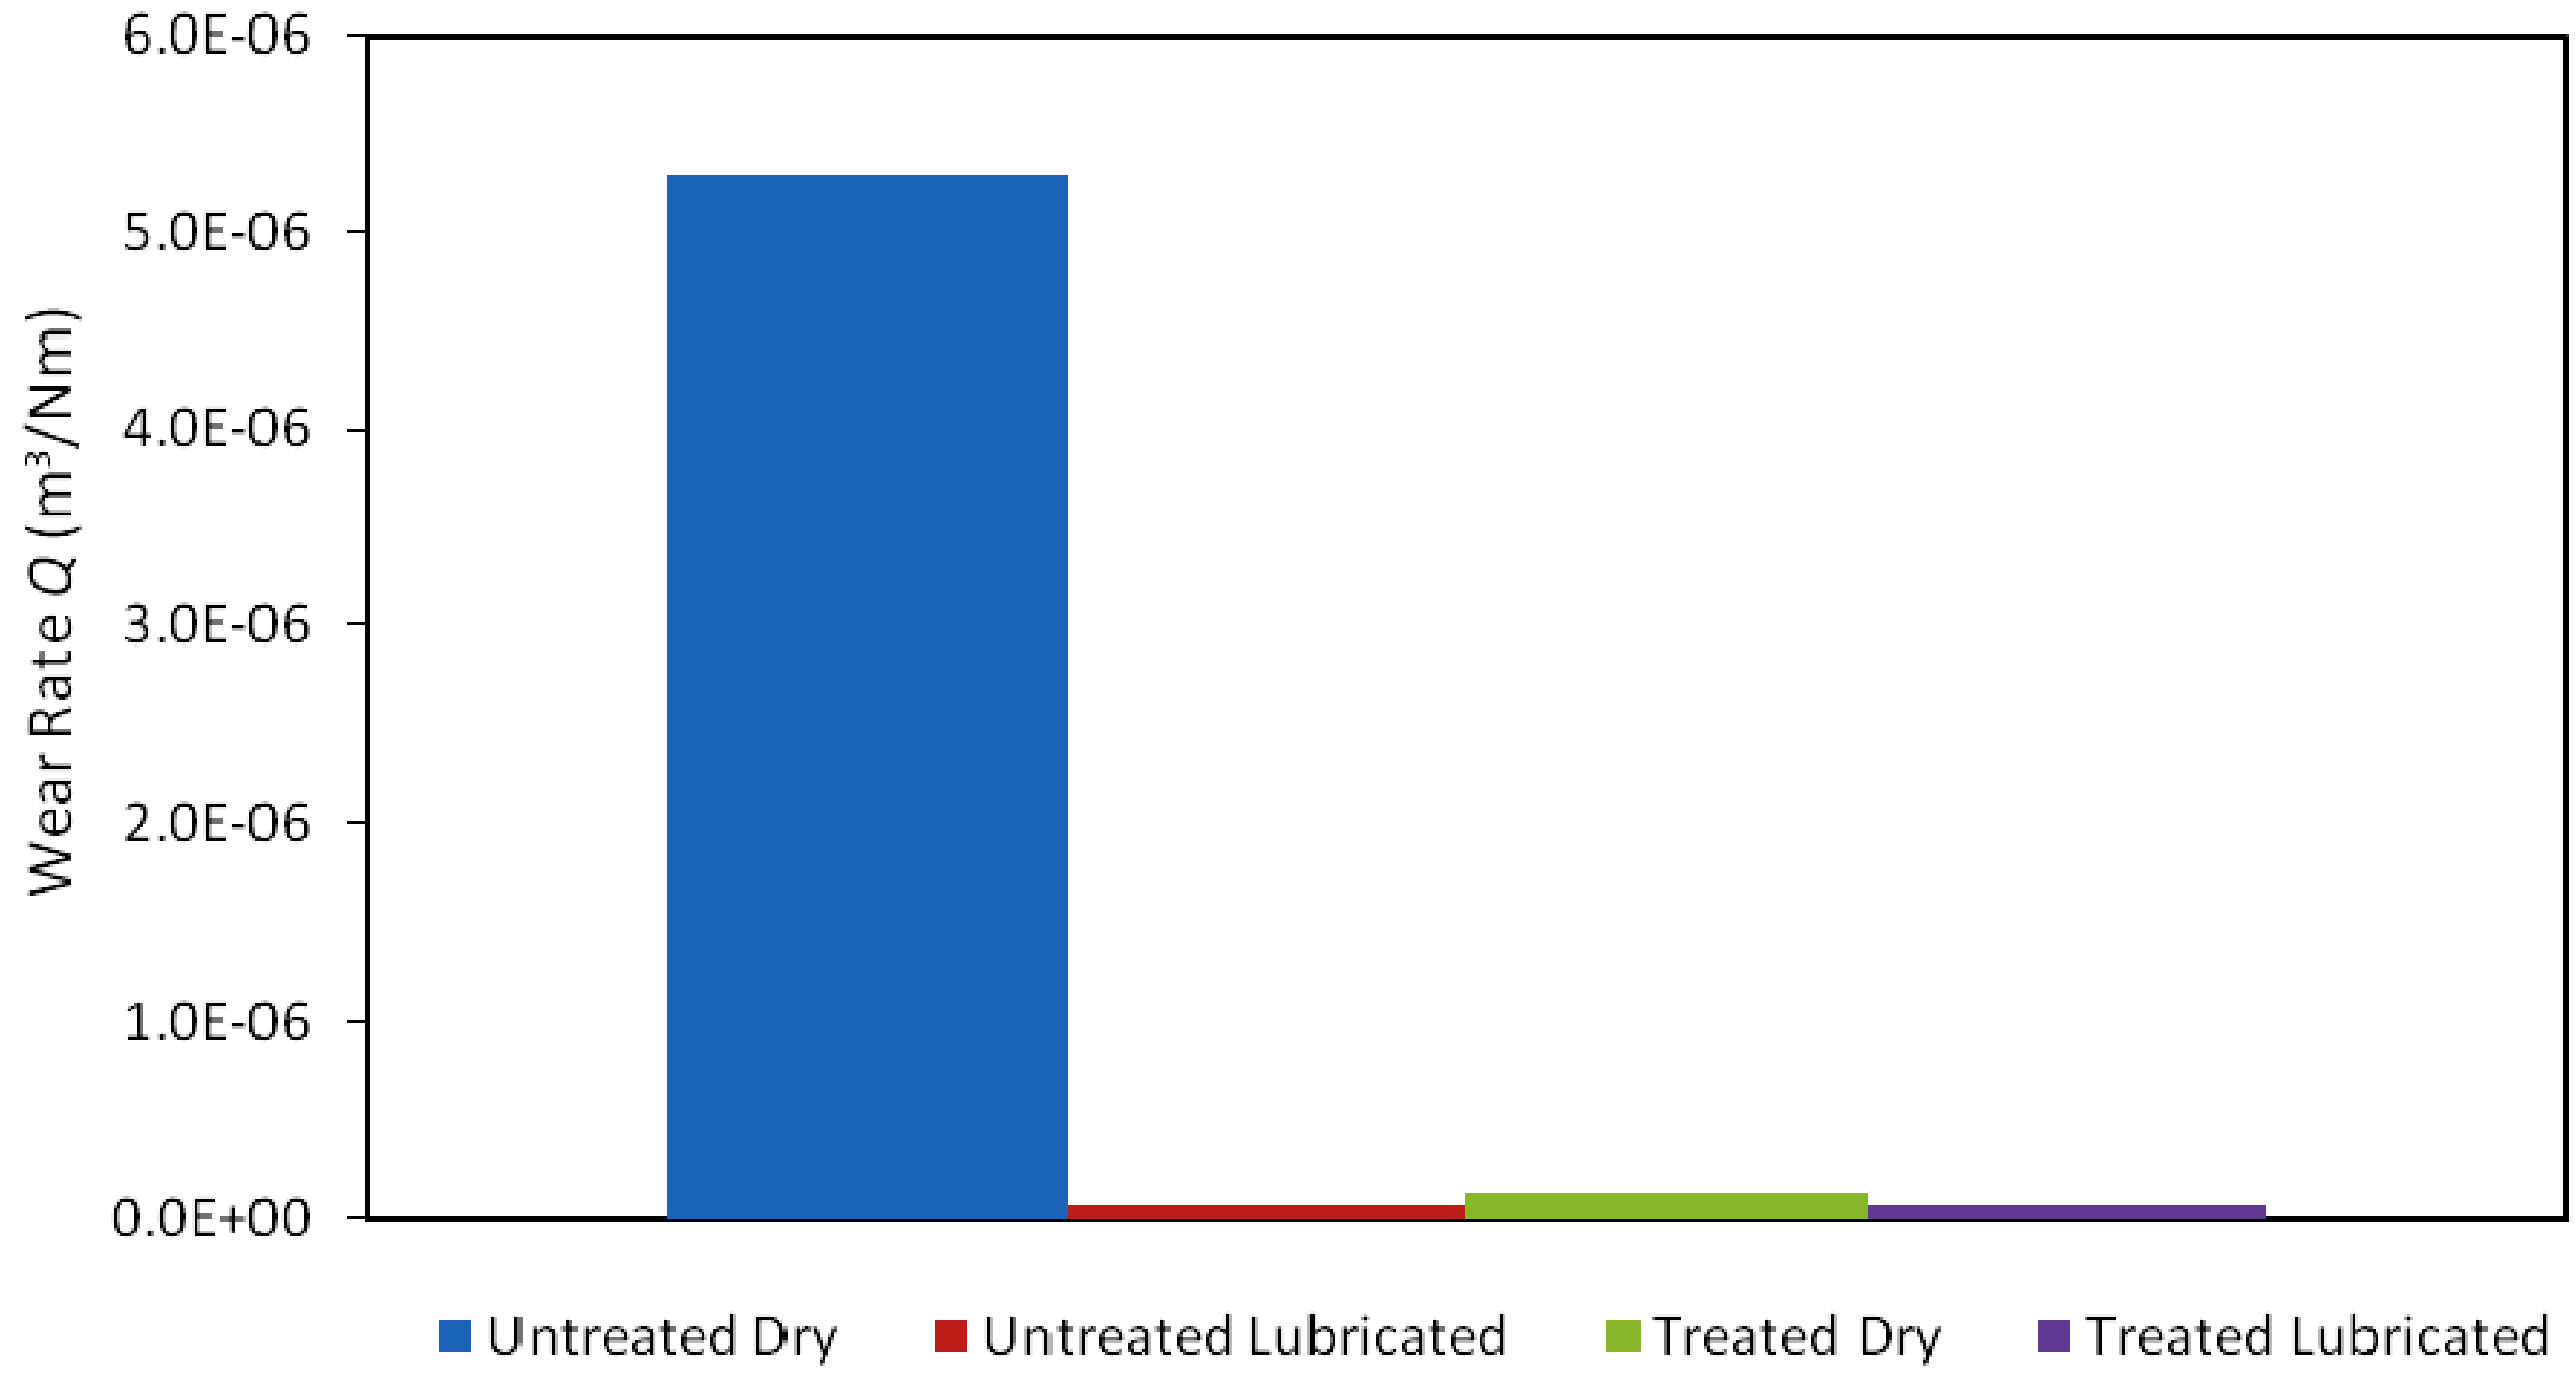
Figure 9. Wear rate *Q*

Figure 9 displays the wear rate *Q* and Figure 10, indicates the wear coefficient *k*, calculated from the wear tests. The highest values were for the untreated AISI 9840R material. As can be observed for steel with nitriding in dry condition low wear rate was observed and similar to the values for untreated and treated AISI 9840 steel in lubricated condition.

The wear rate was high for the untreated AISI 9840 R steel. In the test the AISI 5150 H steel is continuously in contact producing a grooving action and transferring material onto the AISI 9840 R steel. For the treated AISI 9840, the wear rate was low compared to the untreated dry test. The lowest wear rate was in lubricated conditions compared to the dry conditions tests for the treated and untreated material. Though the results are very promising the option of applying lubricant instead of nitriding in the actual components was discarded by the company. They preferred to continue carrying out the holing operation with no lubricant at all. It was believed that a lubricated system may increase the maintenance costs, since nitriding the actual components is more convenient and changing the cylinders in case of failure. They did not consider the cost of the thermal chemical diffusion process whatsoever.

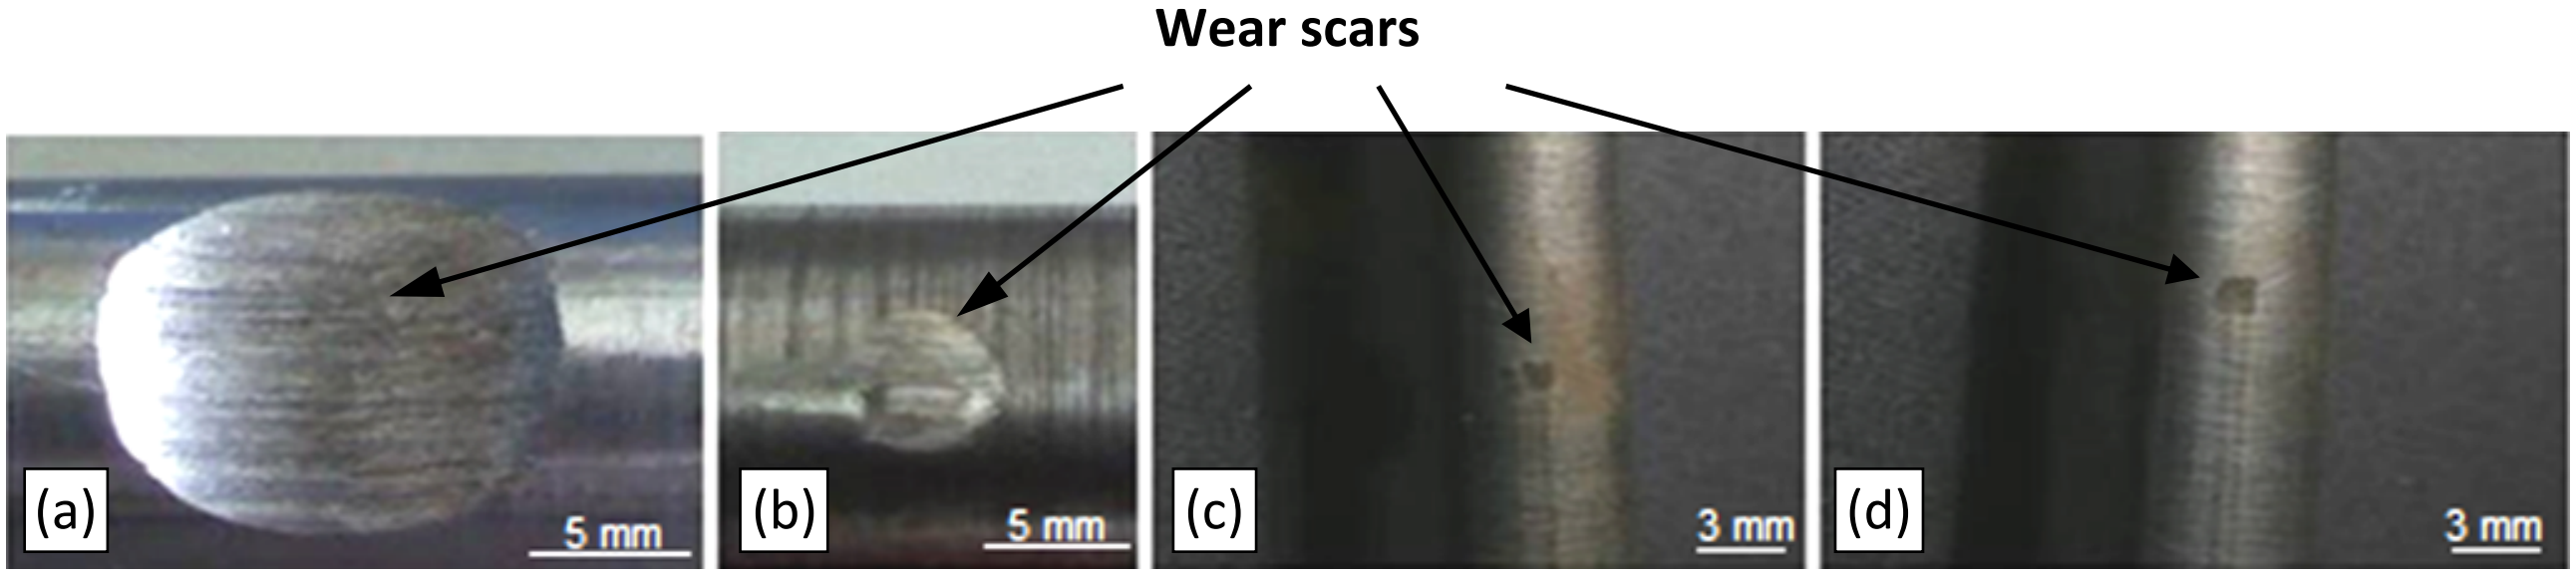
Figure 11. Wear scars for AISI 9840 R steel: (a) dry condition untreated, (b) dry conditions treated (c) lubricated untreated and (d) lubricated treated

Images of the wear scar of the tested AISI 9840 R steel specimens are seen in Figure 11, (a) big wear scar was obtained for the untreated dry test following by a treated dry test (see Fig. 11b). The smallest wear scars were obtained in lubricated conditions for untreated and treated materials (see Figs. 11c and 11d, respectively).

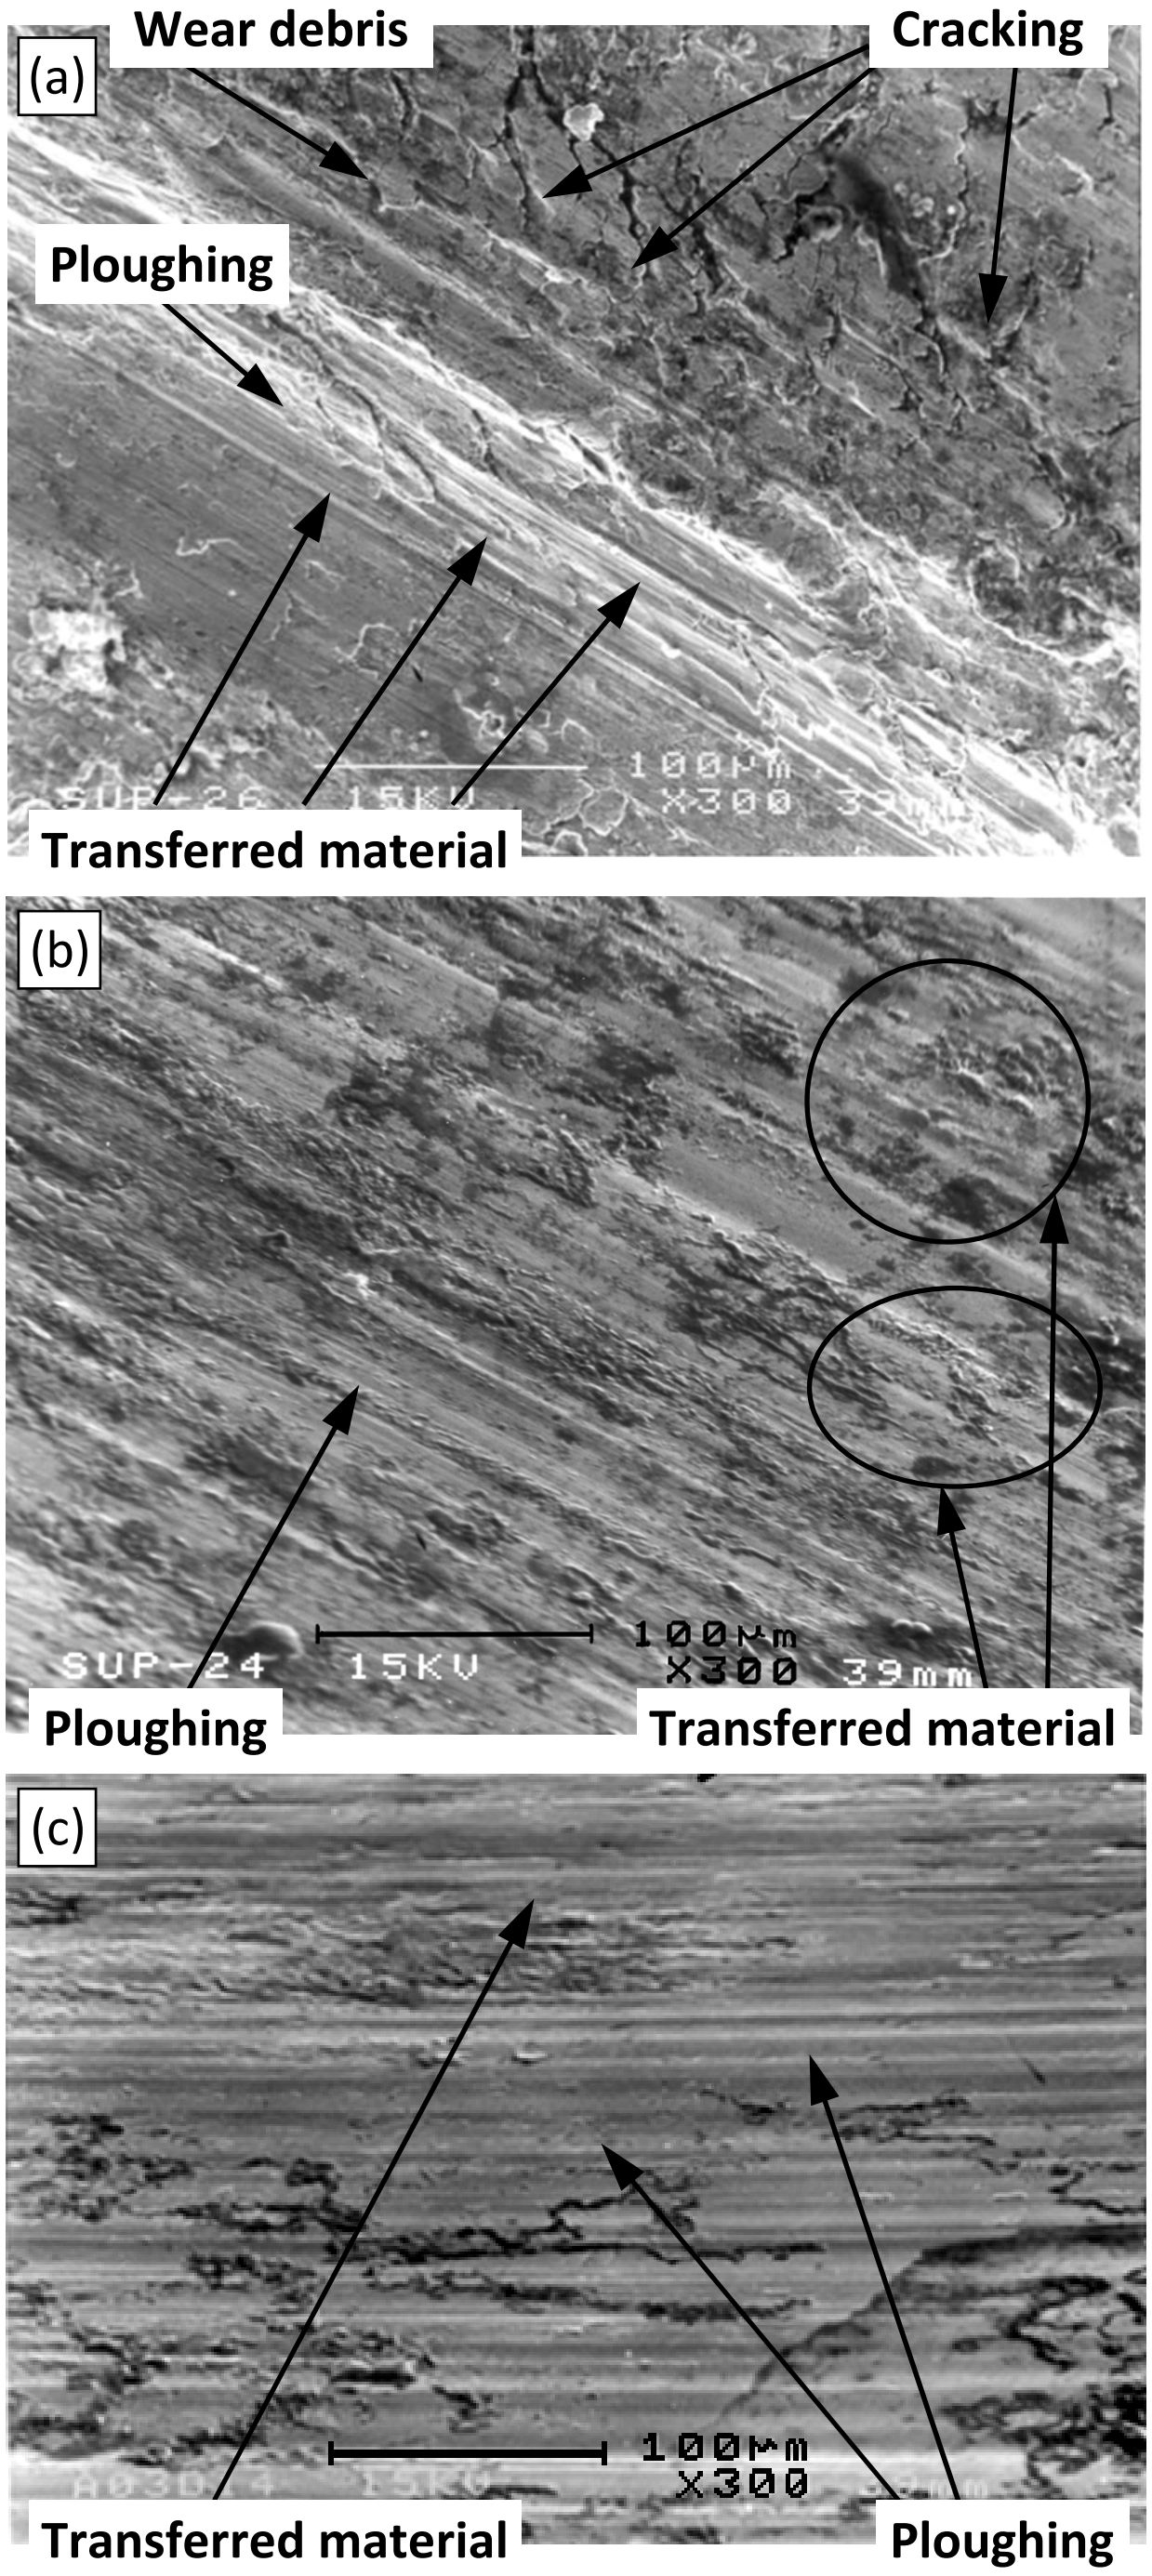
Figure 12. Micrographics of AISI 9840 R steel: (a) untreated dry test, (b) lubricated and untreated and (c) treated dry steel

The wear features are seen in the Figure 12a shows that some material has been transferred from the counter-face and some wear debris produced, some sort of cracking is also observed. Figure 12b shows little material transferred and some ploughing action. In lubricated conditions, in Figure 12c for treated and untreated, ploughing, material transfer and cracks were observed [4].
