**BALKANTRIB'05**  
**5<sup>th</sup> INTERNATIONAL CONFERENCE ON TRIBOLOGY**  
**JUNE.15-18. 2005**  
**Kragujevac, Serbia and Montenegro**

**COMPARATIVE INDICATORS OF THE TRIBOLOGICAL  
CHARACTERISTICS OF THE REGENERATED GEARS  
REPARATORILY HARDFACED BY VARIOUS  
PROCEDURES**

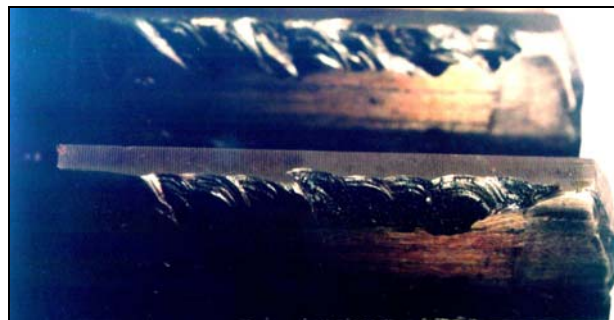
**Figure 5:** Working surfaces of the teeth hardfaced with additional material UTP 670 after  $98 \cdot 10^6$  cycles

The first initial pits in the teeth hardfaced with DM UTP 570 were spotted in the transition of the two passages (facings), which is situated on the head of the tooth. They appeared after  $70 \cdot 10^6$  cycles. After  $98 \cdot 10^6$  cycles, about 32% of the working surface of the most endangered tooth was damaged (Figure 5). It must be noticed that mainly heads of these teeth were damaged, while on the other surfaces separate pits of smaller dimensions and less depth are noticed.

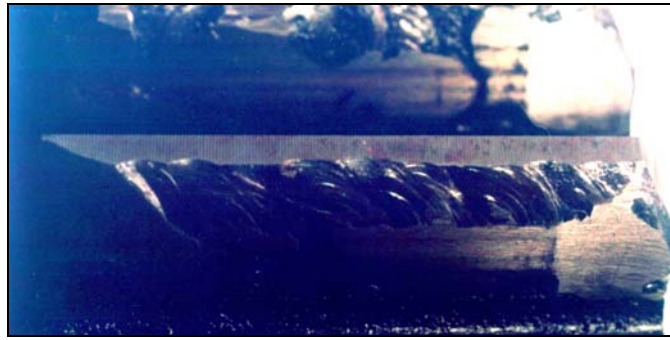
**Figure 6:** Teeth damaged by pitting and hardfaced with additional material EVB2CrMo after  $98 \cdot 10^6$  cycles

At the teeth MMA hardfaced with electrode EVB2CrMo, and then cemented, tempered and released, the incidence of the initial pits is noticed after  $70 \cdot 10^6$  cycles. The legs of the teeth, as well as the heads were destructed, but the

bridging over of these independently created damages by wedges which are almost vertically in relation to the direction of the tooth is also noticed (Figure 6). After the ceasing of investigation (since  $98 \cdot 10^6$  cycles were realized)

the surface which was influenced by the destructive pitting totalled around 50% of the

total working surface of the side of tooth.

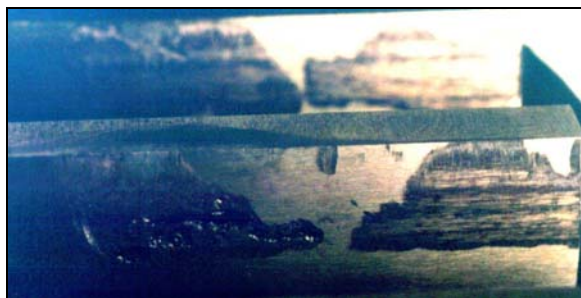
**Figure 7:** One of the initial phases of the destructive pitting of the working surfaces of the teeth of the newly-made gears

The beginning of pitting, that is the incidence of the initial pits, regarding the newly-made teeth, is noticed very early, at the  $69 \cdot 10^6$  cycles. Gradually and very slowly, the other pits started to appear. The incidence of the initial fatigue holes at the teeth of the newly-made gears is the “privilege” exclusively of the leg of the tooth. Only considerably later (after 12-15 million of cycles), the signs of the destructive pitting started to appear also on the legs of the new teeth. On Figure 7 pits created under the diameter pitch of the tooth in the phase immediately before the creation of the wedge are clearly noticed. The special interesting thing is the data that also on the photograph the change of the colour of the working surfaces of

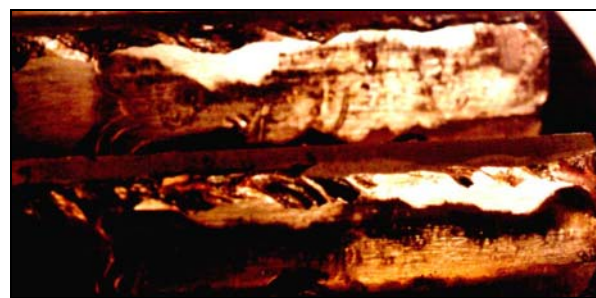
**Figure 8:** Newly-made teeth damaged by the destructive pitting after  $98 \cdot 10^6$  cycles

the teeth due to fatigue, which precedes the creation of the destructive pitting, can be easily seen. The fact is that the development of the destructive pitting regarding the new teeth is a little bit slower than regarding the regenerated ones. At the completing of the investigation, that is after  $98 \cdot 10^6$  cycles, it is estimated that 18% of the working surface of the side of the tooth is affected by pitting (Figure 8).
