WEAR OF STEEL AGAINST CARBON FIBRE REINFORCED PPS

Quintelier J.¹, Samyn P.¹, De Baets P.¹, Ost, W.¹, Van Paepegem, W.²

¹Laboratory Soete, subdivision Tribology and Fatigue, Ghent University, Belgium

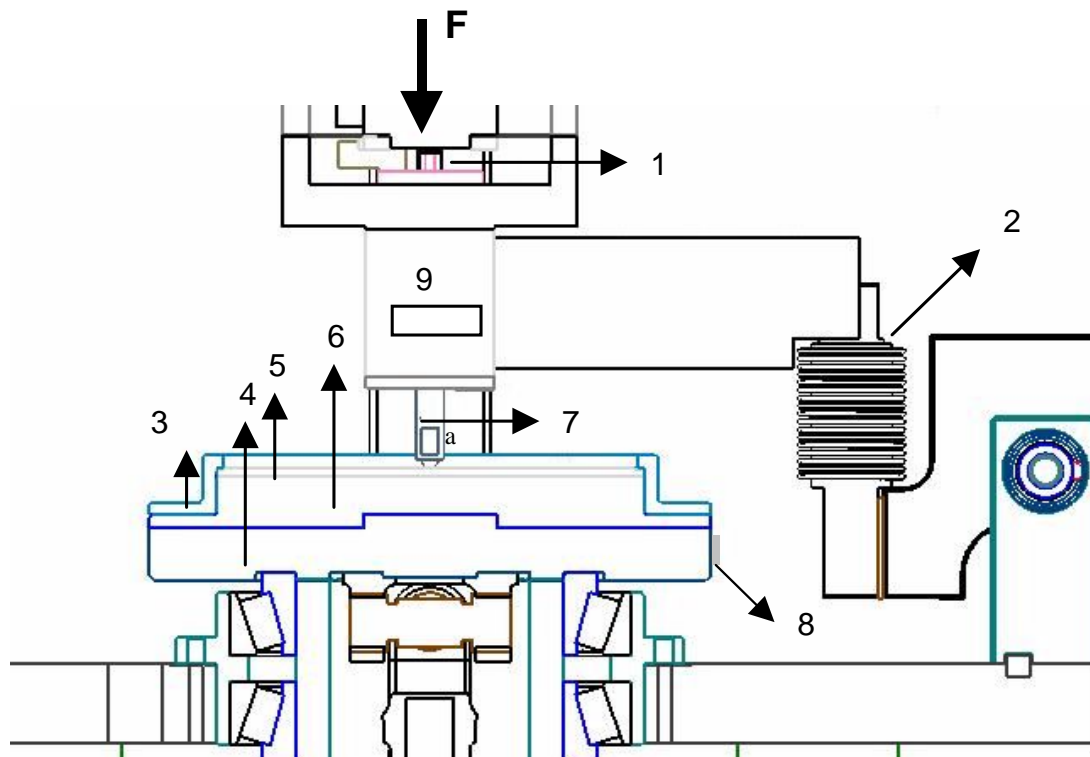
Fig. 2: Pin-on-disc test rig, with (1) normal load cell, (2) friction load cell, (3) ring for keeping the composite disc fixed and in the centre, (4) fixed disc on the test rig, (5) composite disc, (6) removable disc where the composite test specimen is glued on, (7) pin, (8) magnets for triggering, (9) contactless proximitor counter face

The pin (7), made of steel, with a length of 35 mm is hollow at the top, because measuring bending of the pin with strain gauges requires a sufficient strain in the steel pin. Two flat parallel faces close to the contacting surface are places for an accelerometer (see Fig. 2,a) and an acoustic emission sensor. Thermocouples can be placed all over the pin geometry. A ball from a deep groove ball bearing forms the mating surface, or the top of the pin. Thus the pin can be reused, while only the ball has to be replaced.

A new pin-on-disc test rig (Fig. 2) was built in order to be able to monitor the tribological behaviour of composite materials as bearing material. The materials on the most common pin-on-disc set-up [11-14] (composite pin/steel disc) were switched, namely a composite disc and a steel pin were used. This yields the possibility that in one test the influence of the fibre orientation on wear and friction can be investigated by choosing an unidirectional fibre reinforced composite.

For the measurement of the wear depth of the wear track, a contactless proximitor (9) is used, providing an estimate of the evolution of the wear depth with time.

For measuring the normal force on the pin a load cell is placed above the pin (1). This load cell is protected by a spring mechanism, which allows pressing directly on the load cell, without damaging this load cell. Another method to measure the normal force on the pin is by measuring the air pressure in the cylinder used

as supplier for the normal force. This cylinder is connected via valves to the compressor. The friction force is measured with a load cell (2).

On the rotating disc, magnets (8) are placed, which are used as trigger for the various signals, but are also used to synchronize measured friction and wear signals with the fibre orientation. This type of indication is very reliable, and gives the possibility to calculate the values of the friction force related to a specific orientation (0° , 90° , 180° , 270°).

On a steel disc (6), the composite disc (5) is fixed with bee wax. Due to high frictional loads

this might not prevent rotation of the disc, therefore the disc is kept in place with an external ring (3). This ring not only presses slightly the composite disc onto the steel disc at the edge, but also makes sure that the composite disc stays centered to the rotation, yielding a perfectly circular wear pattern on the disc. This replaceable disc construction is then placed on a fixed disc (4). The whole disc construction rests on two bearings, and is driven by the axis of a reduction unit, which itself is driven by an asynchronous motor through a speed reducer and a timing belt.

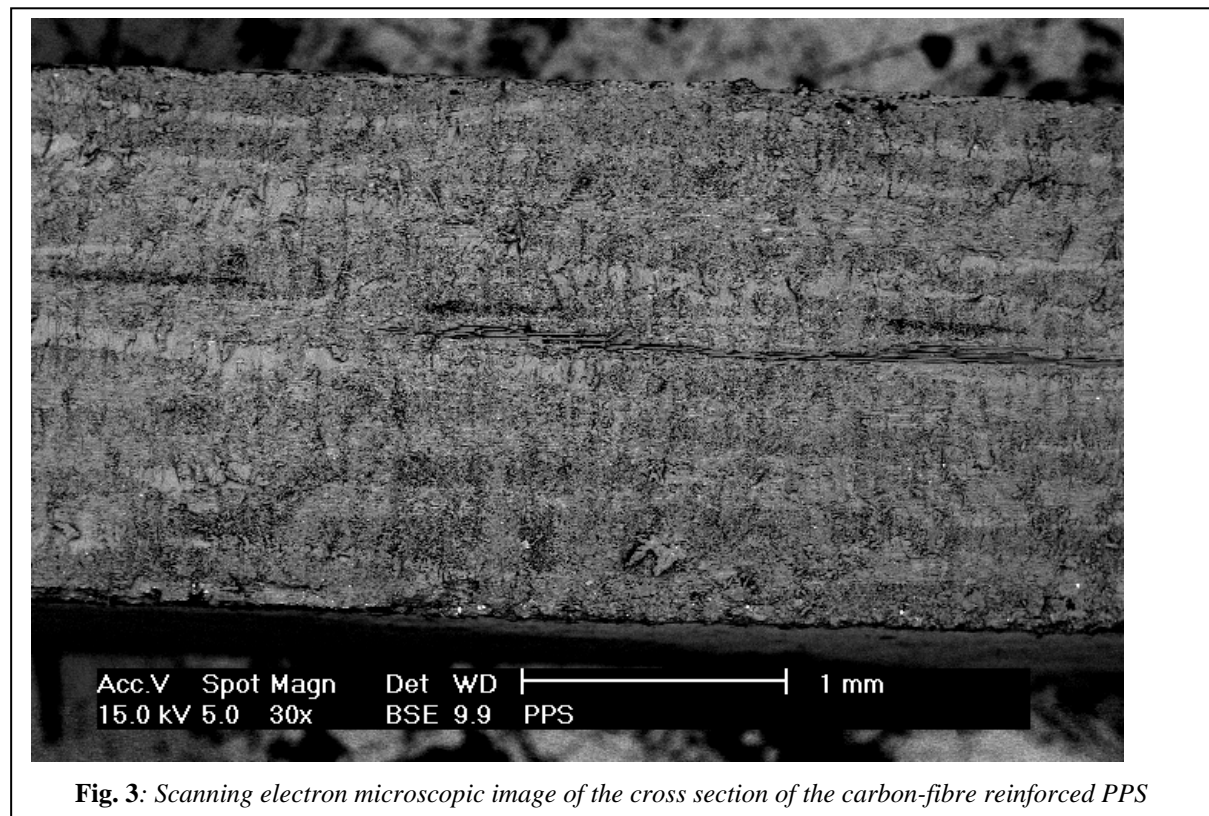
Fig. 3: Scanning electron microscopic image of the cross section of the carbon-fibre reinforced PPS

The fibre-reinforced composite under study was a 5-harness satin (see Fig. 4) weave carbon/PPS composite. Poly phenylene sulphide (PPS) is a commonly used thermoplastic matrix in aeronautical applications. Eight layers of fabric were stacked in sequence $[0^\circ/90^\circ]_{2s}$, the angle indicates the warp direction of the reinforcement layer. This result in a carbon content of $50 \pm 3\%$. Discs were cut out by water jet process, and a cross section of the material is shown in fig 3. The white zones constitute pure PPS, while the dark zones represent carbon fibres.

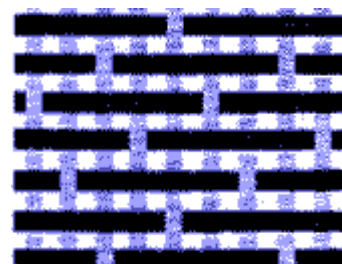
Fig. 4: Schematic diagram of 5-harness satin weave

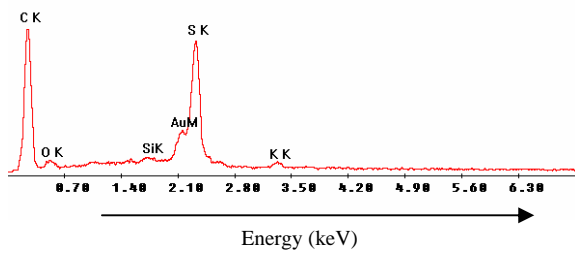
Fig. 5: EDX spectra of the area in fig 3.

The EDX-spectrum of this cross section (Fig. 5), shows high peaks of C (Carbon) and S

(Sulphur). Also Au (gold) is found in minor amounts. This is due to the fact that the sample was pre-treated with a minor amount of gold for higher contrast SEM images. The peaks of Si (Silicon) and K (Potassium) originate from the abrasives used in water jet cutting.

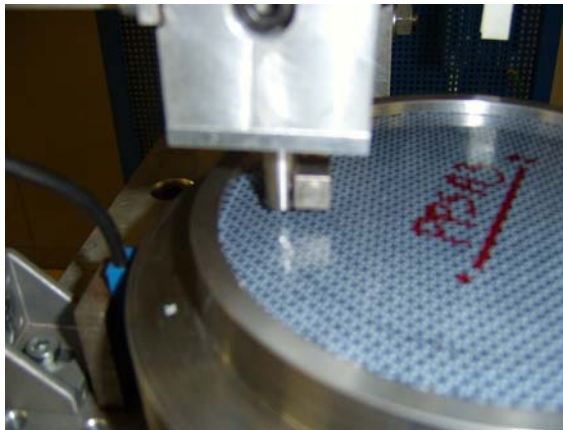
Fig. 6: Pin-disc configuration, closer look at contact zone

Carbon fibre reinforced PPS-discs were mounted on the removable disc (fig 2, 6). A closer look on the test set up is given in Fig. 6. The test parameters were 250N normal load and a relative velocity of 20 mm/s. A test consisted of 10.000 revolutions with a sliding distance of 400 mm per revolution, yielding a total sliding distance of 4 km.

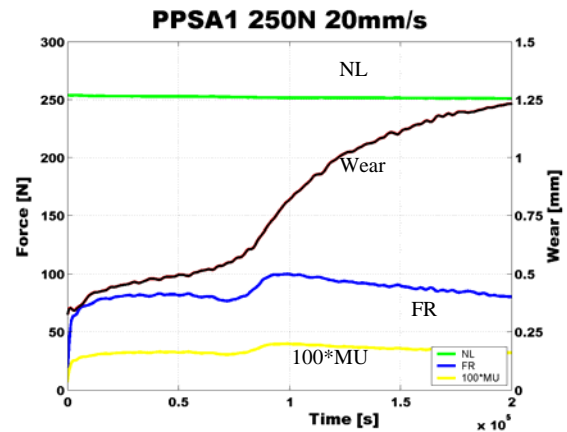
Fig. 7: Test results at 250N, 20mm/s (Disc PPSA1) with the upper line the normal load (NL, left axis), the 2 lowest lines are the friction force (FR, left axis) and the coefficient of friction multiplied by 100 (100*MU, left axis), also indicated on the left, while the second line from above is the evolution of the wear depth (right axis)

Results of the tests performed at 250 N and 20mm/s are presented in figs. 7 and 8. In these graphs, the wear and frictional behaviour of the pin-disc material combination is plotted as a function of the time. Each point of the curvature is obtained by averaging 250 points, measured at 50Hz of each round, so each curve in the graphs of Fig. 7 and Fig. 8 consists of 10.000 points.

At a constant normal load (250N) the evolution of wear is rather exceptional. After a small running in period, the composite wears very slowly, until, at a certain moment (75.000 s), the wear depth increases very strongly. Just before the rise in wear rate, the friction force decreases, then rises when the wear rate rises, and lowers again linearly after 100.000 s. The total wear depth after testing is 0.95mm.

While in Fig. 7 the wear rate increases after 75.000 s, in Fig. 8 the increase of the wear rate starts after 115.000 s. The rest of the graph is exactly the same, as well in evolution in time as in magnitude.

The differences between the two tests are due to differences in material structure. Although all the discs had the same stack sequence ($[0^\circ/90^\circ]_{2s}$), a small difference in thickness of the outer PPS layer is possible. The plates for both tests were cut-out from plates made by compression moulding. This technique makes differences in thickness of top layers possible, due to the flow of the thermoplastic polymer, in this case the PPS [15-16]. The difference in thickness of the PPS layer above the first carbon fibres explains the difference in time between Fig. 7 and Fig. 8.

In the wear track a carbon film is formed. This film lowers the coefficient of friction, (around 75.000 s and 115.000s respectively). But also the formation of this carbon film increases the wear rate of the pin.

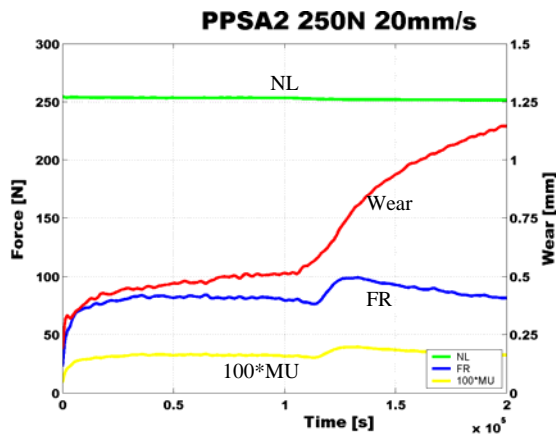
Fig. 8: Test results at 250N, 20mm/s (Disc PPSA2) with the upper line the normal load (NL, left axis), the 2 lowest lines are the friction force (FR, left axis) and the coefficient of friction multiplied by 100 (100* μ , left axis), also indicated on the left, while the second line from above is the evolution of the wear depth (right axis)

A second test (Fig. 8) performed under the same conditions shows an identical phenomenon, albeit somewhat later on in the test.

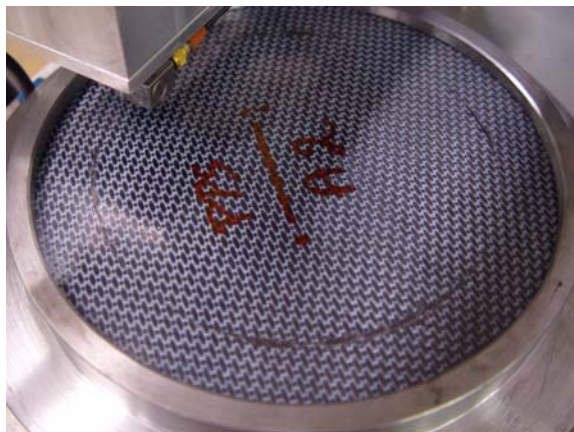
Fig. 9: Image of the wear state of disc PPSA2 after 450 rounds

Fig. 9 shows the wear track of the disc after 450 rounds. As fig 9 shows, the width of the wear track on the disc correlates with the fibre orientation. The 0° (parallel fibre orientation relative to the direction of motion) and the 90° (indicated via the line in the middle of the disc) orientation have an earlier wear through the top layer of PPS than the 45° , and perpendicular (90°) orientation has an earlier wear through than the parallel (0°) as shown by the larger wear track at the 90° orientation.

The wear behaviour vs. time can be explained as follows. At the beginning of the test the contact between pin and disc is a point contact, resulting in very high contact pressures. As the top layer of the plate is pure PPS this yields a rather large plastic deformation of the PPS layer. As shown in Fig. 9, break through this PPS layer does not happen at the same time all over the disc. The influence of the orientation of the fibres in the upper fabric, gives an earlier break through for perpendicular orientation to the direction of motion, followed by the parallel orientation, and finally the 45° orientation. This break through could also be visualized when monitoring a full round, where the wear depth changed in relation to the position of the disc. After a completed wear track is formed, carbon starts playing an important role in the friction and wear behaviour.

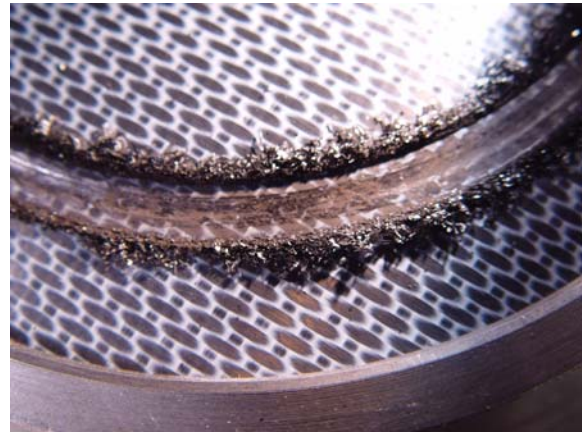
Fig. 10: Wear track of disc PPSA2, after 9000 rounds.

At the end of the test (Fig. 10) wear debris can be seen next to the wear track, almost equally divided between the inner diameter and the outer diameter of the wear track. Interesting to note is that between the two edges with wear debris, two flat zones are visible where carbon fibres and PPS (as in the original top view of the

disc) can be seen, while in the middle between the wear debris wear track can be seen. These two flat zones does not seem to have suffered from any wear (original surface), while in the middle of the wear track, a carbon (black) film is visible.

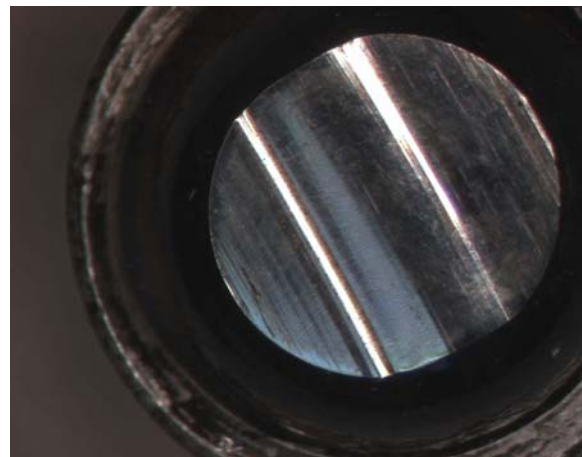
Fig. 11: Resulting contact area of pin after 4 km at 20 mm/s and 250N normal load.

After testing also post mortem images were taken. For instance the worn pin is shown in Fig. 11 the left side on this picture corresponds with the inner diameter of the wear track; right corresponds with the outer diameter of the wear track.

Due to the lighting a curved zone in the middle of the pin can be observed. At the edges of the pin two flat zones are present, with grooves in the direction of motion. The higher middle zone is not right, but follows a certain curvature.

The worn pin top, with two flat zones, besides a higher zone in the middle, is due to third body abrasion. Carbon particles, and steel particles after initial wearing of the pin, were pressed outside the wear track. This results in wear debris next to the edges and play a role as third body particles.

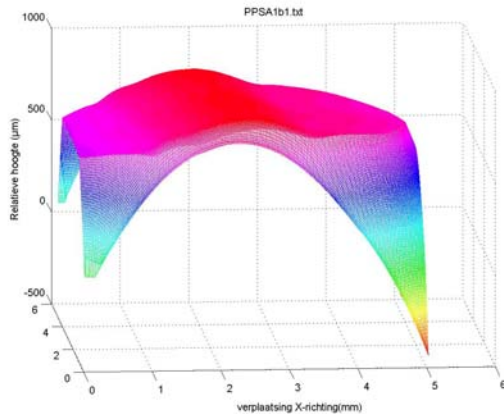
Fig. 12: 3D-scan of final pin top after testing

A 3D scan of the worn pin top was taken. The result (see Fig. 12) reveals a zone, which is higher than the two flat zones at the sides.
